## FEASIBILITY STUDY

PREPARED FOR:  
GRANITE COUNTY MUSEUM &  
CULTURAL CENTER  
135 S SANSOME ST  
PHILIPSBURG, MT 59858

PREPARED BY:  
HIGH PLAINS ARCHITECTS  
2720 MINNESOTA AVE  
BILLINGS, MT 59101

**GRANITE COUNTY MUSEUM & CULTURAL CENTER**

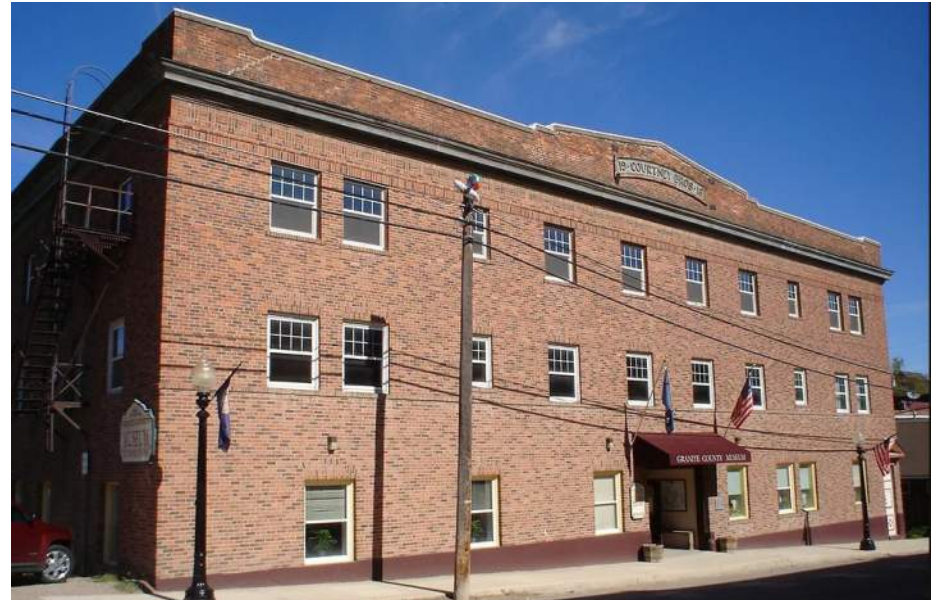
East Facade, 2023

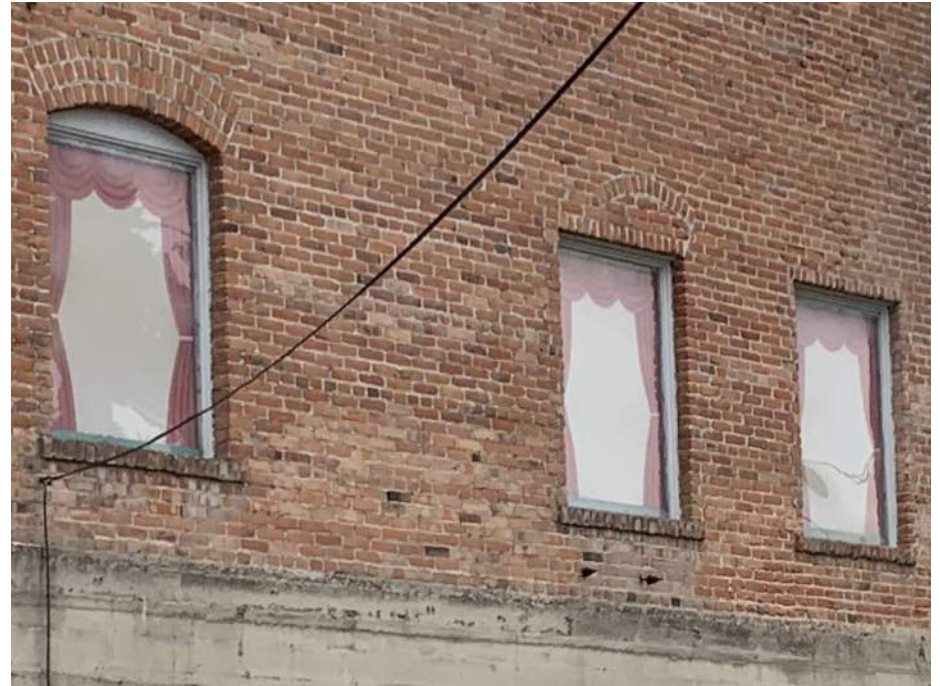
Covered windows & previous door location on the west facade.

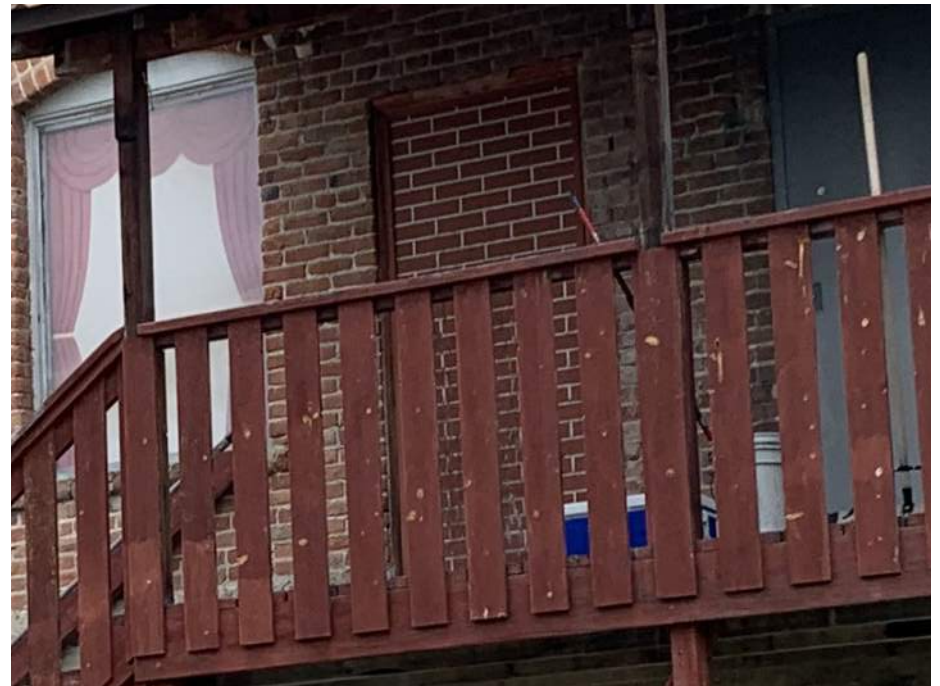
Previous door opening infilled with masonry at the exterior west egress stair.

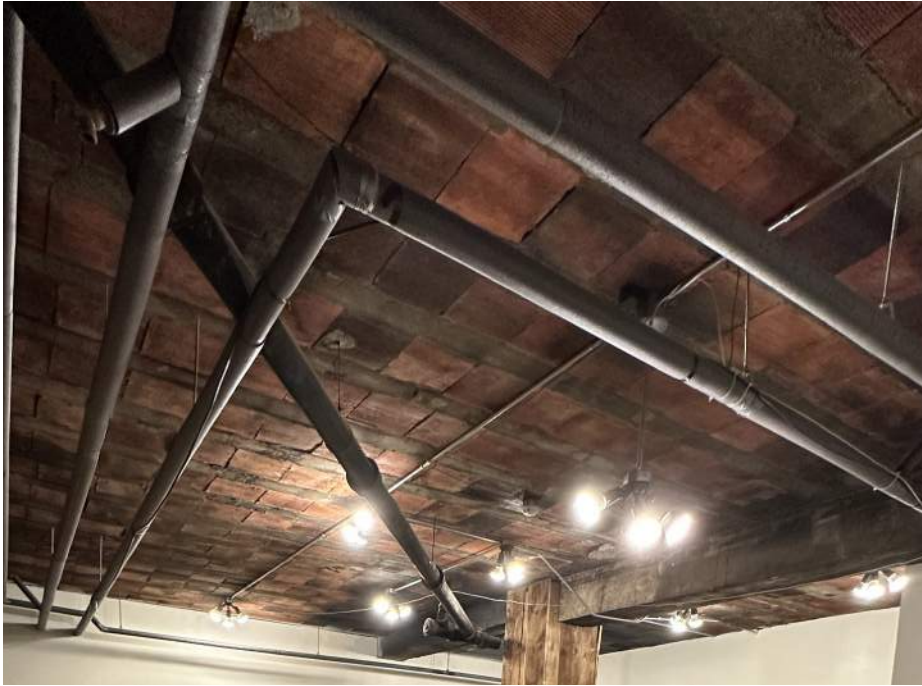
Exposed clay tile ceiling from the one-way clay tile joist system.

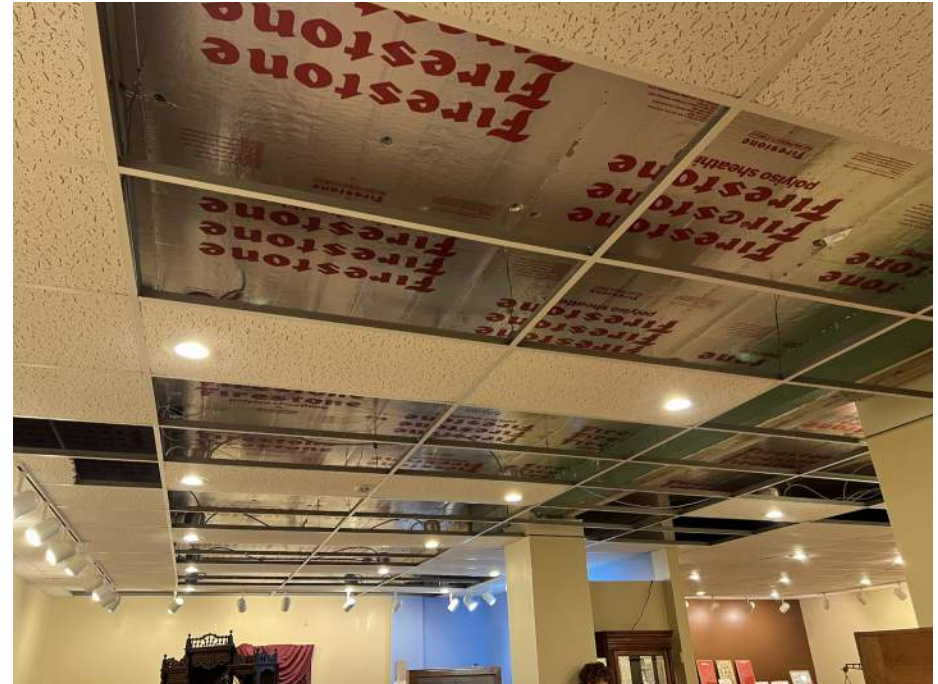
First floor ACT ceiling & insulation.

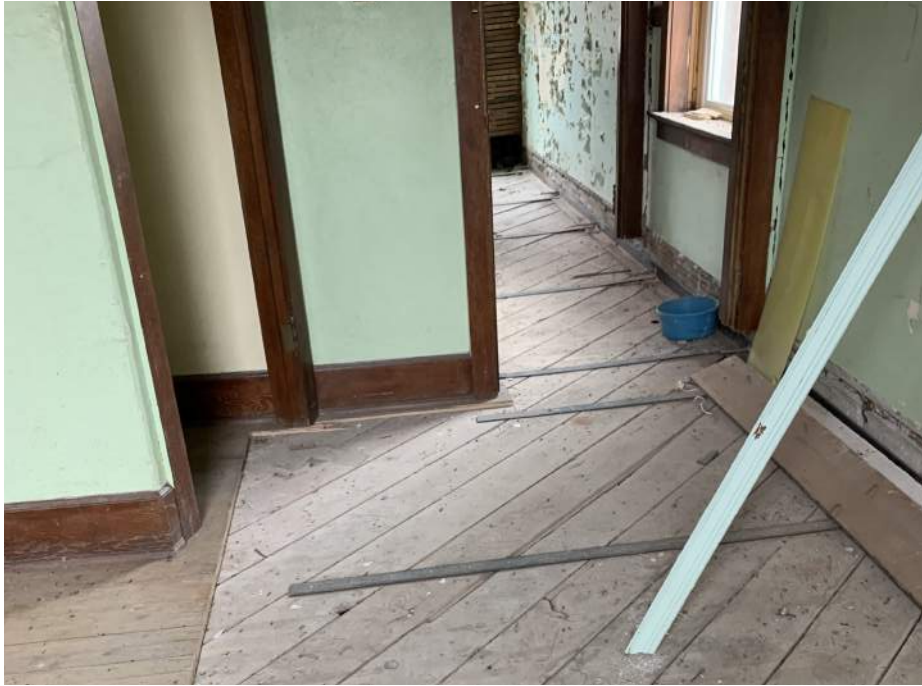
Third floor structural strapping.

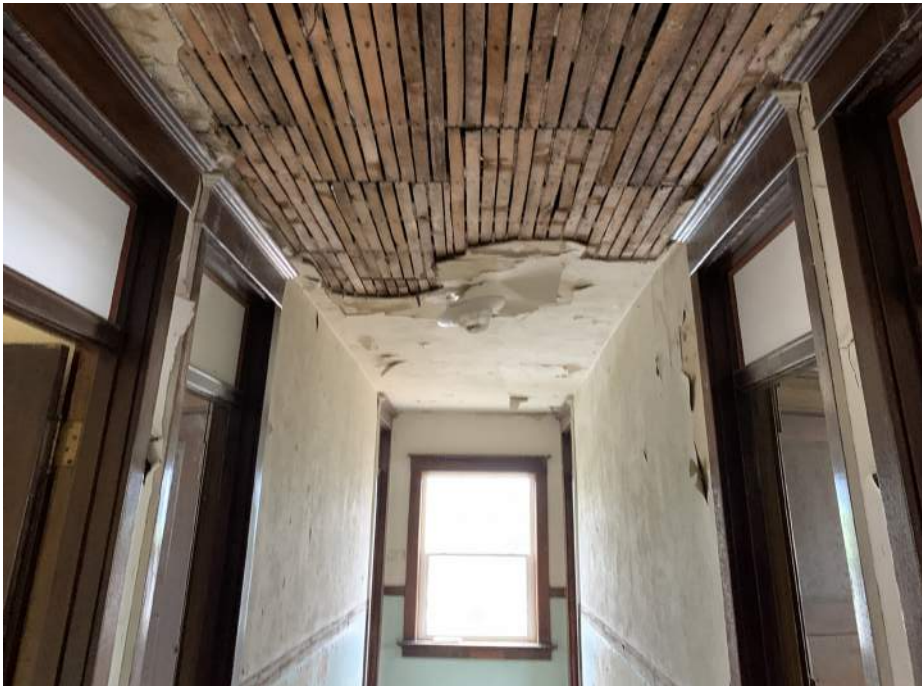
Third floor hall finishes.
